Home Inspection Report

123 Main Street
Clearwater, FL 33762

Prepared for: Ray & Janet Sample

Prepared by: Square-One Inspection Service, LLC
11705 Boyette Rd. Suite 404
Riverview, FL 33569

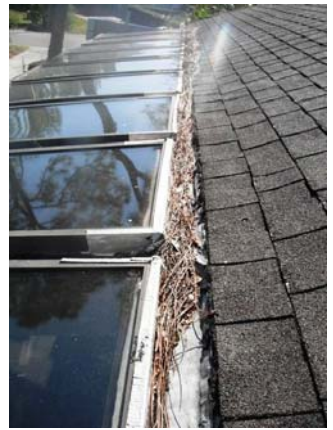
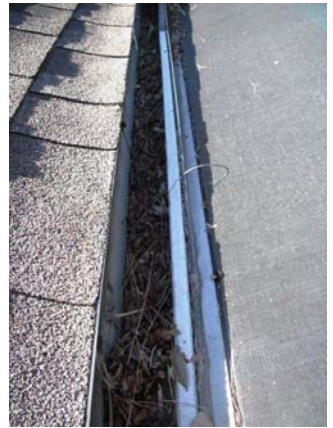
1. Master Bathroom Roof Surface Material: **Rolled roof material - Further Investigation Required - Roof shows signs of deterioration, the roof is the near end of its useful life. This roof is no longer shedding water properly and is leaking, failure imminent, extended life not expected.**

The roof is a poor design and most likely has leaked somewhere throughout it's lifetime this is a potential major repair if it were determined a full replacement were warranted. The best solution might be a new modular roof engineered & built off site.

2. Gutters: **Aluminum - Gutters are full of leaves & debris, will need to be cleaned before rainy season begins. Furthermore some of the gutters at the rear of the home where the screen enclosure meets the house has leaking seams which will need to be repaired.**

- I NP NI D
8. Material: **Rolled roof material - Further Investigation Required - Roof shows signs of deterioration, the roof is the near end of its useful life. This roof is no longer shedding water properly and is leaking, failure imminent, extended life not expected.**

- I NP NI D
9. Flashing: **Aluminum**
 10. Plumbing Vents: **Lead Encased PVC**
 11. Gutters: **Aluminum - Gutters are full of leaves & debris, will need to be cleaned before rainy season begins. Furthermore some of the gutters at the rear of the home where the screen enclosure meets the house has leaking seams which will need to be repaired.**

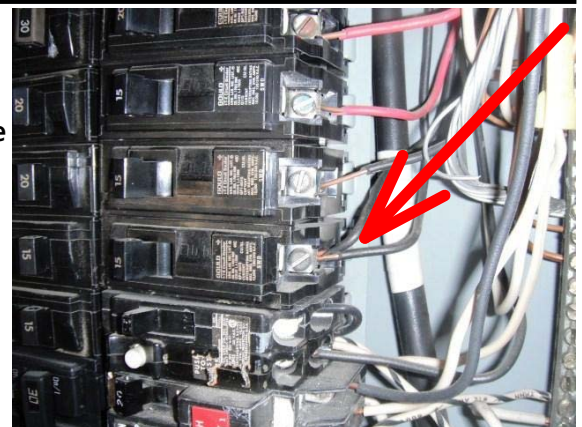
3. Garage Electric Panel Breakers: **Snap-In - Minor Repair - Double taps are present at breakers. These circuits need to be moved to their own circuit breaker and cannot share a breaker. It is recommended that a qualified electrician inspect the new circuits and properly connect the new circuits to an individual breaker for each circuit**

| 8. | <input type="checkbox"/> | <input type="checkbox"/> | <input type="checkbox"/> | <input checked="" type="checkbox"/> | Breakers: Snap-In - Minor Repair - Double taps are present at breakers. These circuits need to be moved to their own circuit breaker and cannot share a breaker. It is recommended that a qualified electrician inspect the new circuits and properly connect the new circuits to an individual breaker for each circuit |

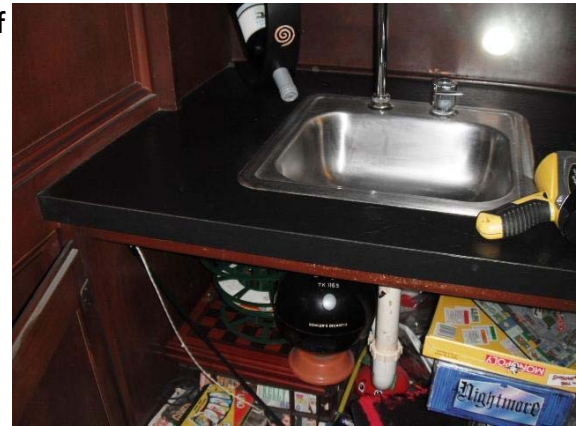
6. Bar Sink: Stainless Steel - The bar sink was not in service at the time of inspection the service valves under the tub were off which usually means there is some kind of leaking issue.

| 10. | <input type="checkbox"/> | <input type="checkbox"/> | <input type="checkbox"/> | <input checked="" type="checkbox"/> | Bar Sink: Stainless Steel - The bar sink was not in service at the time of inspection the service valves under the tub were off which usually means there is some kind of leaking issue. |

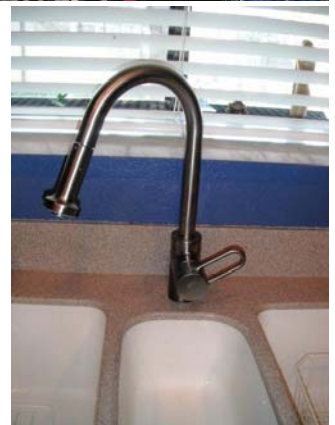
7. Faucets/Traps: Delta fixtures with a metal trap - At the kitchen sink the hot and cold operation is reversed.

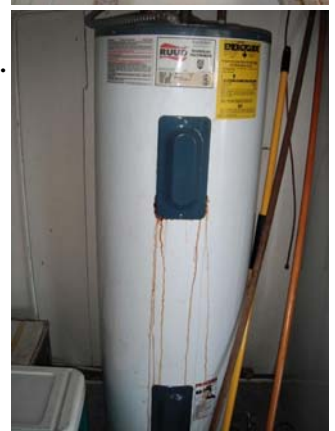
8. Garage Water Heater Water Heater Operation: Functional at time of inspection - This water heater appears to have leaked in the past and will most likely need to be replaced. The water heater is near the end of it's expected service life. Since there is no way to predict when this unit could fail, we recommend having it replaced at the earliest opportunity, so as to prevent any damage that could occur as a result of a sudden rupture of this aging tank.

19. Water Heater Operation: **Functional at time of inspection** - This water heater appears to have leaked in the past and will most likely need to be replaced. The water heater is near the end of it's expected service life. Since there is no way to predict when this unit could fail, we recommend having it replaced at the earliest opportunity, so as to prevent any damage that could occur as a result of a sudden rupture of this aging tank.

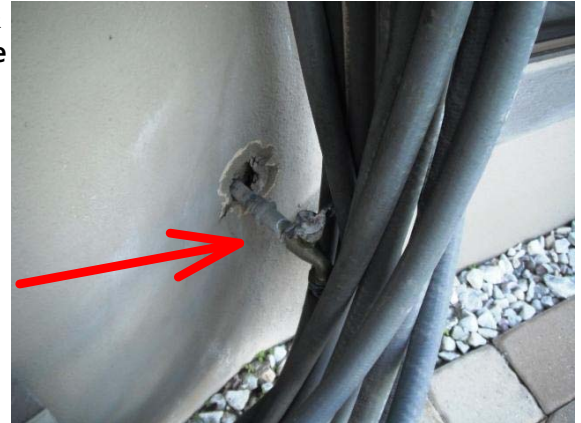
9. **Hose Bibs: Gate - Minor repair** - It is recommended that the leaking & loose hose bib at the left side of the house be properly secured to the wall.

I NP NI D
30. Hose Bibs: **Gate - Minor repair** - It is recommended that the leaking & loose hose bib at the left side of the house be properly secured to the wall.

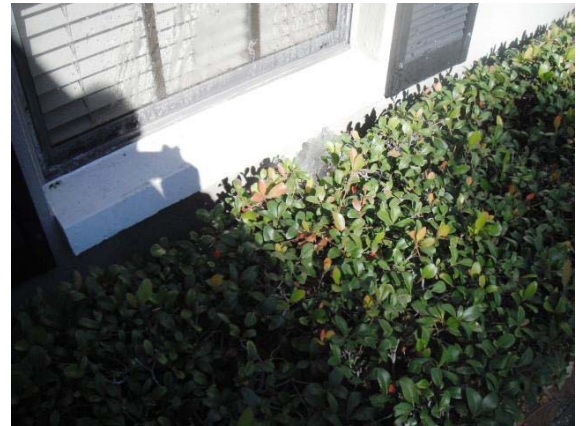
10. **Lawn Sprinklers: Front and back yard** - The lawn sprinkler system has broken heads throughout and there appears to be a broken line on the east side of the home, once the system is fully repaired it will need to be tested and adjusted so that no water is spraying onto the home.

31. Lawn Sprinklers: **Front and back yard** - The lawn sprinkler system has broken heads throughout and there appears to be a broken line on the east side of the home, once the system is fully repaired it will need to be tested and adjusted so that no water is spraying onto the home.

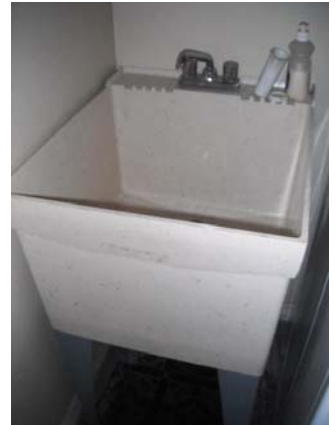
11. **Laundry Tub: PVC** - The laundry tub was not in service at the time of inspection the service valves under the tub were off which usually means there is some kind of leaking issue.

I NP NI D
32. Laundry Tub: **PVC** - The laundry tub was not in service at the time of inspection the service valves under the tub were off which usually means there is some kind of leaking issue.

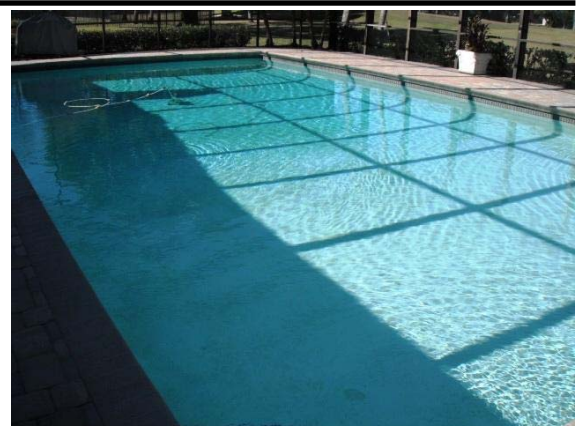
12. **Behind home Swimming Pool Liner: Concrete** - The underwater pool surface appears to be pitted (typical of aging). Although this surface may be considered cosmetic, the Buyer is encouraged to seek the opinion of a pool specialist regarding the current condition and remaining life expectancy of the underwater surface.

| 11. | <input type="checkbox"/> | <input type="checkbox"/> | <input type="checkbox"/> | <input checked="" type="checkbox"/> | Liner: Concrete - The underwater pool surface appears to be pitted (typical of aging). Although this surface may be considered cosmetic, the Buyer is encouraged to seek the opinion of a pool specialist regarding the current condition and remaining life expectancy of the underwater surface. |

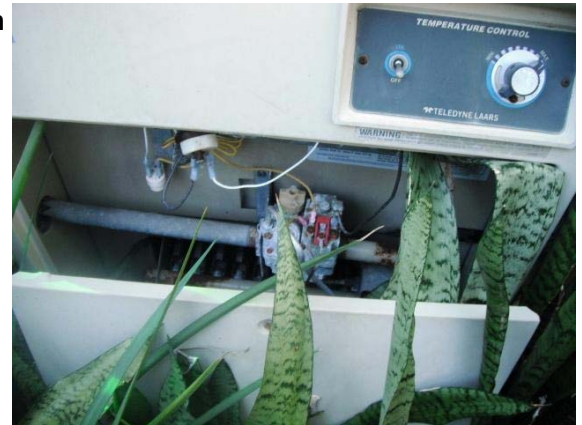
13. Behind home Swimming Pool Heater: Propane - Further Investigation Required - The unit appears to be defective the control panel was open for servicing and the the controls did not work.

| 17. | <input type="checkbox"/> | <input type="checkbox"/> | <input type="checkbox"/> | <input checked="" type="checkbox"/> | Heater: Propane - Further Investigation Required - The unit appears to be defective the control panel was open for servicing and the the controls did not work. |

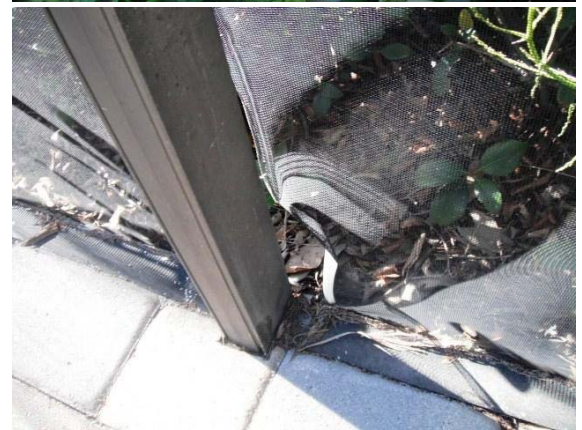
14. Behind home Swimming Pool Pool Enclosure: Fiberglass Screen - Further Investigation Required - All of the screen material is nearing its end of life some screens are torn I suggest having a professional determine if it is better to repair or replace screen material.

| 19. | <input type="checkbox"/> | <input type="checkbox"/> | <input type="checkbox"/> | <input checked="" type="checkbox"/> | Pool Enclosure: Fiberglass Screen - Further Investigation Required - All of the screen material is nearing its end of life some screens are torn I suggest having a professional determine if it is better to repair or replace screen material. |

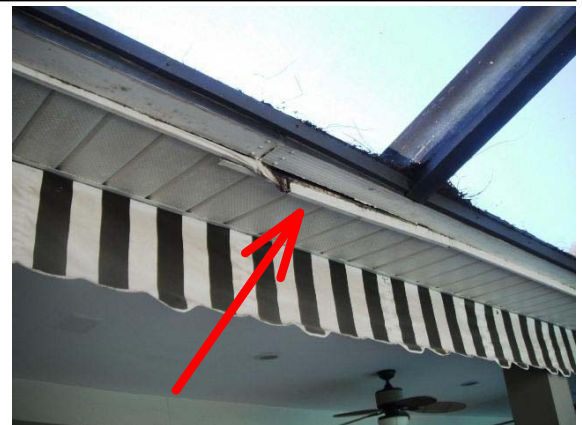
15. Fascia: Wood - Wood decay was observed at the fascia at the rear of the house where the roof meets the screen enclosure. Extensive & costly repair likely due to the fact it is where two structures meet.

| 2. | <input type="checkbox"/> | <input type="checkbox"/> | <input type="checkbox"/> | <input checked="" type="checkbox"/> | Fascia: Wood - Wood decay was observed at the fascia at the rear of the house where the roof meets the screen enclosure. Extensive & costly repair likely due to the fact it is where two structures meet. |

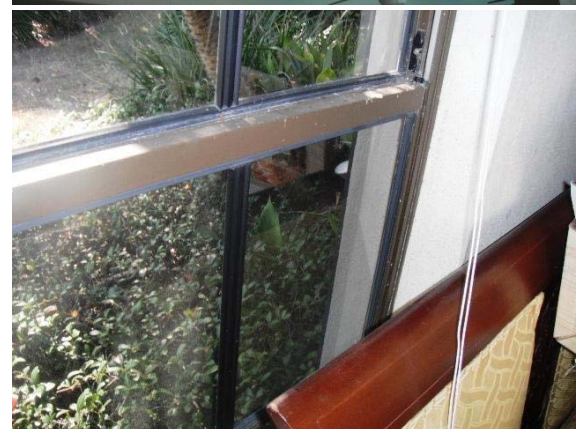
16. Windows: Aluminum Single Hung - Safety Concern - Most of the windows tested in this home have one or both spring sashes damaged and will need to be repaired or replaced. Some windows are jammed closed and refuse to open, others won't stay open once they are raised. In any case since so many of the windows are affected I would suggest having the repair work performed by a professional, costs could easily exceed \$100 per window.

The safety concern exists because in an emergency windows are the secondary means of egress for a bedroom and because they either don't open or won't stay opened there exists a life safety hazard. Please do not disregard having these windows repaired prior to occupancy.

| 8. | <input type="checkbox"/> | <input type="checkbox"/> | <input type="checkbox"/> | <input checked="" type="checkbox"/> | Windows: Aluminum Single Hung - Safety Concern - Most of the windows tested in this home have one or both spring sashes damaged and will need to be repaired or replaced. Some windows are jammed closed and refuse to open, others won't stay open once they are raised. In any case since so many of the windows are affected I would suggest having the repair work performed by a professional, costs could easily exceed \$100 per window.

The safety concern exists because in an emergency windows are the secondary means of egress for a bedroom and because they either don't open or won't stay opened there exists a life safety hazard. Please do not disregard having these windows repaired prior to occupancy. |

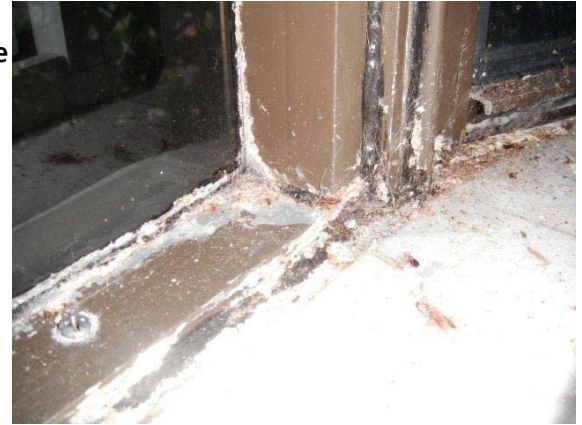
17. Bay Window: Aluminum - Further Investigation Required - The bay window in the dining room is showing signs of decay due to moisture intrusion which has effected the walls and carpet. The window system appears beyond repair and will most likely need to be replaced.

| 9. | <input type="checkbox"/> | <input type="checkbox"/> | <input type="checkbox"/> | <input checked="" type="checkbox"/> | Bay Window: Aluminum - Further Investigation Required - The bay window in the dining room is showing signs of decay due to moisture intrusion which has effected the walls and carpet. The window system appears beyond repair and will most likely need to be replaced. |

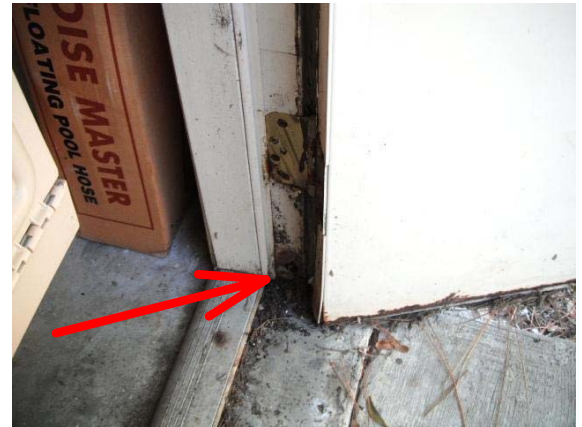
18. Exterior Entry Door: Wood - Rot was observed in the wood frame of the side Garage door. It is recommended that the deteriorated wood be removed and replaced with solid to prevent the condition from growing worse.

| 8. | <input type="checkbox"/> | <input type="checkbox"/> | <input type="checkbox"/> | <input checked="" type="checkbox"/> | Exterior Entry Door: Wood - Rot was observed in the wood frame of the side Garage door. It is recommended that the deteriorated wood be removed and replaced with solid to prevent the condition from growing worse. |

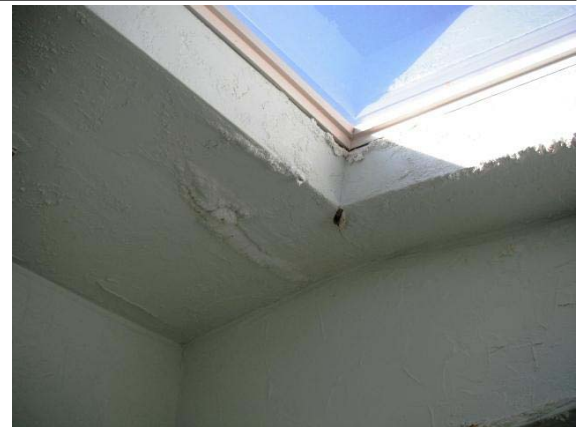
19. Ceilings: Texture paint - Extensive moisture damage in master bathroom see roof section for further information.

| 2. | <input type="checkbox"/> | <input type="checkbox"/> | <input type="checkbox"/> | <input checked="" type="checkbox"/> | Ceilings: Texture paint - Extensive moisture damage in master bathroom see roof section for further information. |

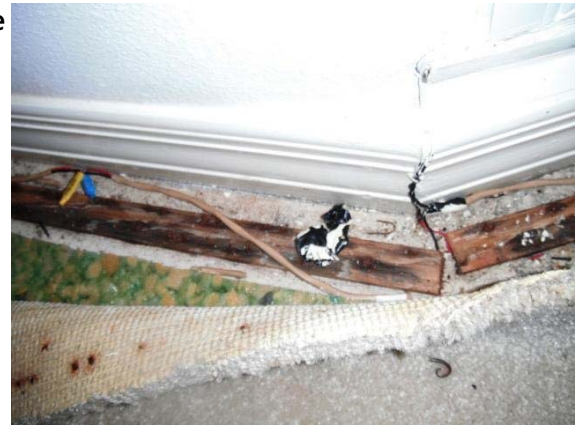
20. Walls: Paint and tile - Some minor wall damage noted from moisture intrusion near the bay window in the dining room.

| 3. | <input type="checkbox"/> | <input type="checkbox"/> | <input type="checkbox"/> | <input checked="" type="checkbox"/> | Walls: Paint and tile - Some minor wall damage noted from moisture intrusion near the bay window in the dining room. |
